ERDC/CHL TR-02-11

Periodic Inspections of Kahului and Laupahoehoe Breakwaters, Hawaii

Armor Unit Monitoring for Period 1992/93-2001

August 2002

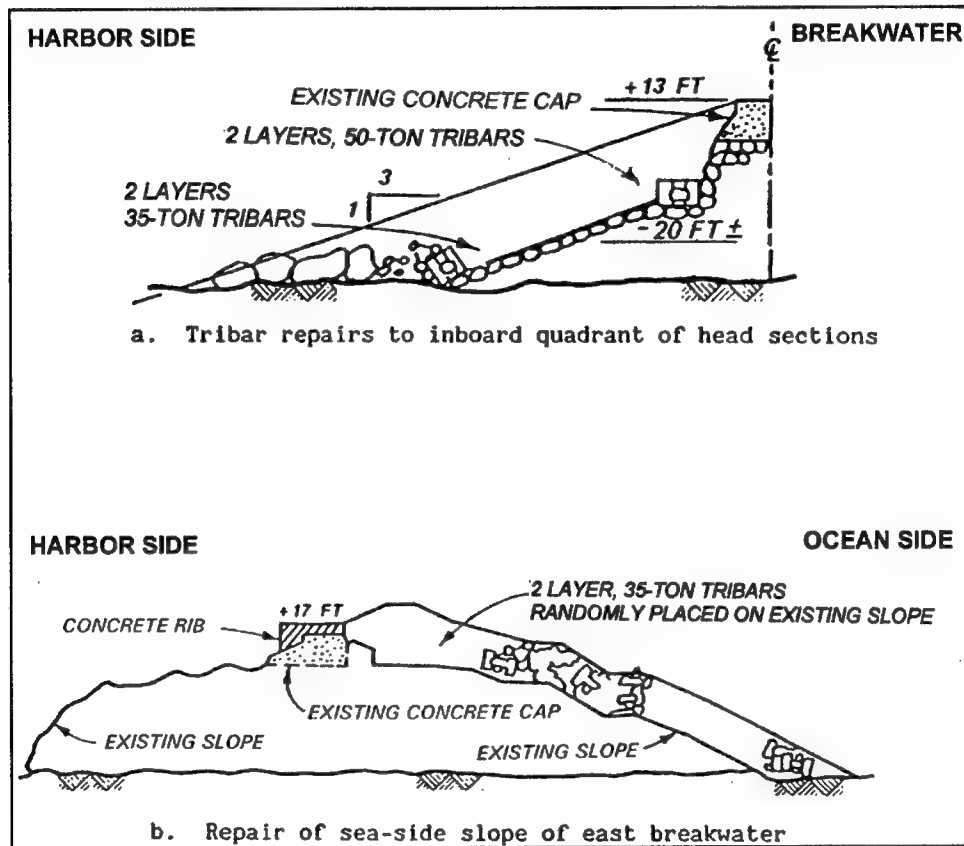
Figure 6. 1996 Kahului breakwater repairs

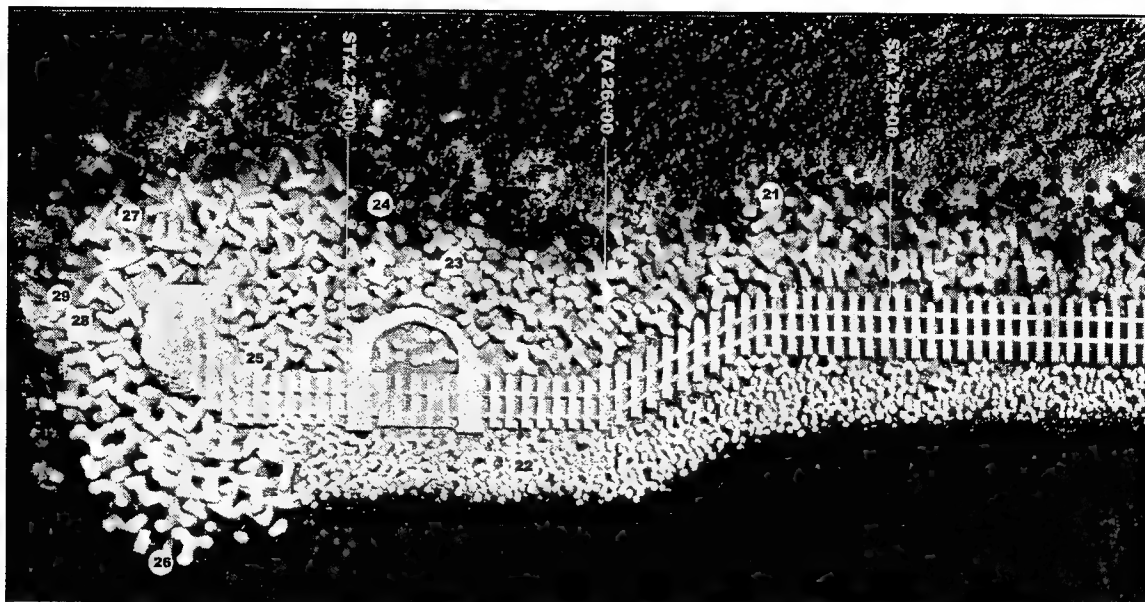
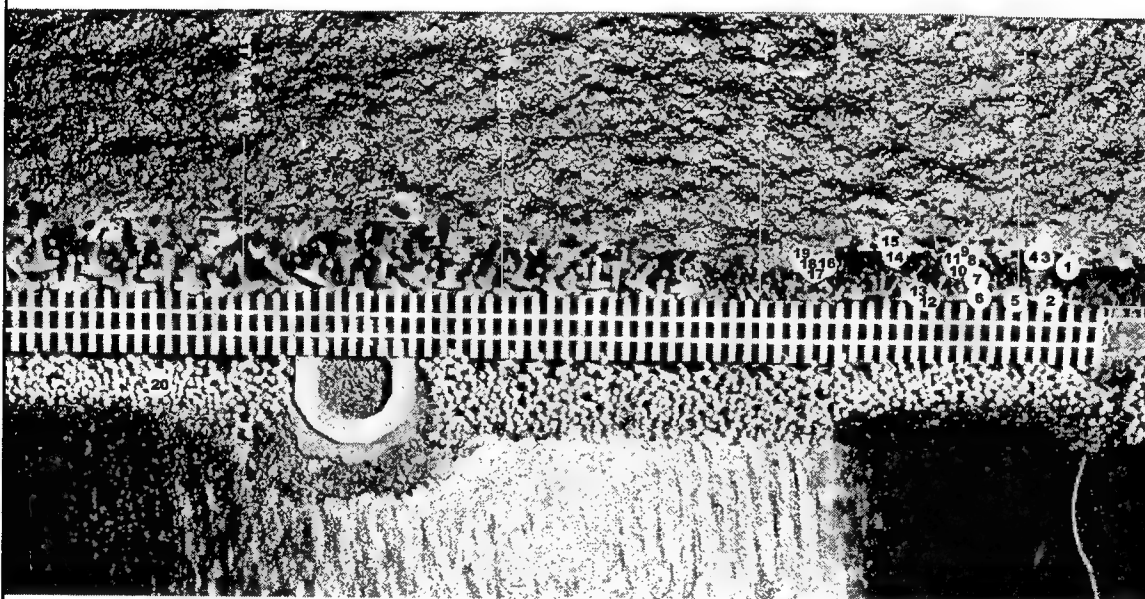
29 broken or cracked armor units were identified and 58 were observed on the Kahului west breakwater during the walking survey. No broken or cracked armor units were found on the Laupahoehoe breakwater .

The approximate locations of broken/cracked armor units along the Kahului east and west breakwaters are shown in Figures 26 and 27, respectively, and detailed data obtained during the broken armor unit inventory are shown in Table 11. Armor unit numbers identified in Figures 26 and 27 correspond to those listed in Table 11. Of the 29 broken armor units on the Kahului east breakwater, 19 were 5,445-kg (6-ton) dolosse; two were 8,165-kg (9-ton) tribars; four were 27,215-kg (30-ton) dolosse; and four were 31,750-kg (35-ton) tribars. The majority of the broken units (66 percent) were 5,445-kg (6-ton) dolosse located on the seaward side of the inner half of the concrete-armored portion of the structure. These broken units were concentrated between stas 19+60 and 20+84. Seventy-four percent of the broken 5,445-kg (6-ton) dolosse were located on the lower portion of the seaward slope in the active wave zone. Most the remaining broken units on the east breakwater were sporadically located around the head of the structure with no specific concentrations. Of the 58 broken armor units on the Kahului west breakwater, four were 5,900-kg (6.5-ton) tribars; one was a 9,980-kg (11-ton) tribar; 16 were 17,235-kg (19-ton) tribars; 18 were 18,145-kg (20-ton) dolosse; 11 were 27,215-kg (30-ton) dolosse; five were 29,940-kg (33-ton) tetrapods; and three were 31,750-kg (35-ton) tribars. On the west breakwater, 90 percent of the broken units were located on the seaward side of the outer half of the concrete-armored section of the breakwater. Concentrations of broken units occurred on the sea side of the breakwater between stas 20+50 and 21+50 and stas 22+50 and 23+50. Most broken units (66 percent) also were located on the lower portion of the seaward breakwater slope in the active wave zone.

Figure 26. Approximate locations of broken/cracked armor units along outer portion of Kahului east breakwater

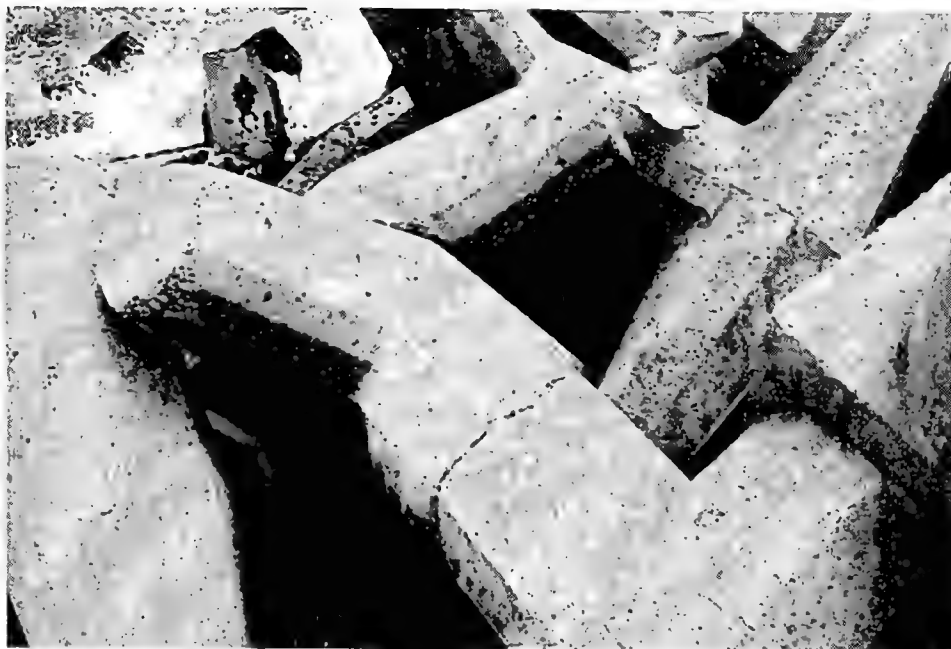
Figure 28. Dolos with mid-shank crack

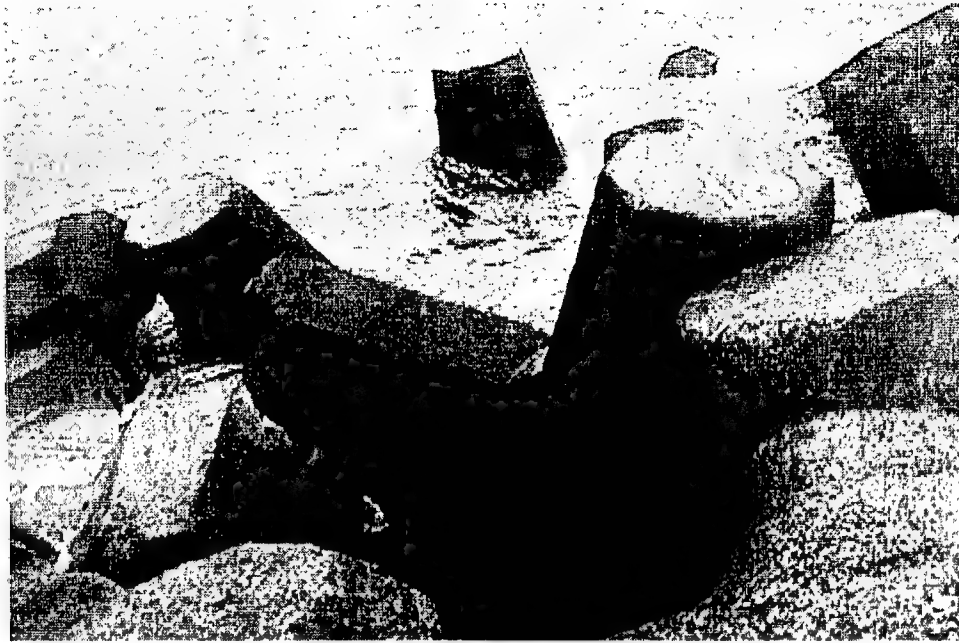
Figure 30. Dolos with shank-fluke break

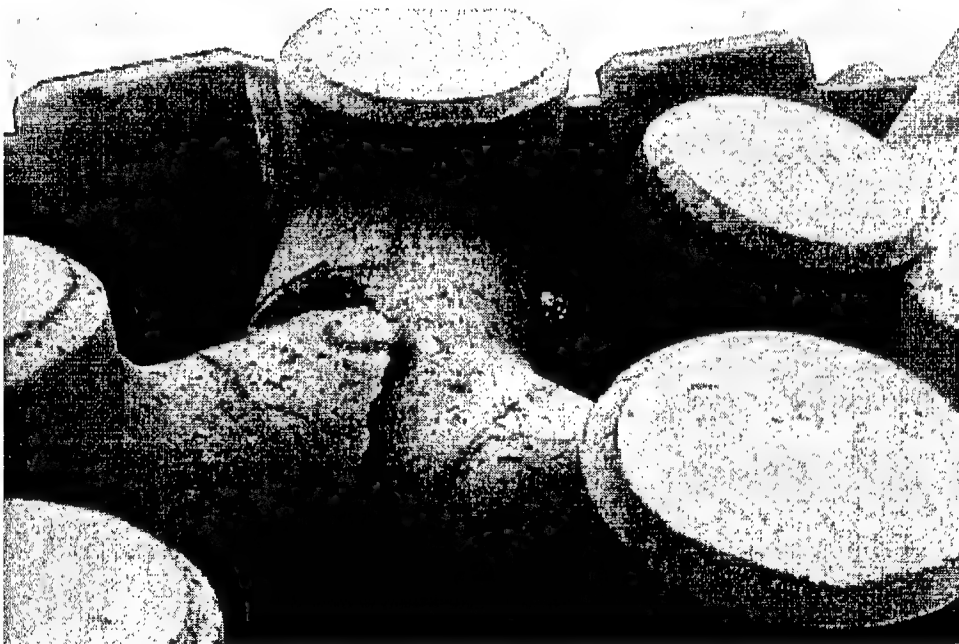
Figure 31. Tribar with break through center section of unit
